**Flood Control Project Maintenance
Levee Inspections**

Maintenance Issue Types Only, Levee Inspection Report By Mile - Fall 2018

Sutter Maintenance Yard East Levee Sacramento River

Waterway	Bank	Unit Miles	Inspection Start/End	Inspector
Unit No. 01 Sacramento River	Left	19.85	10/10/2018 10/10/2018	Bob Duffey

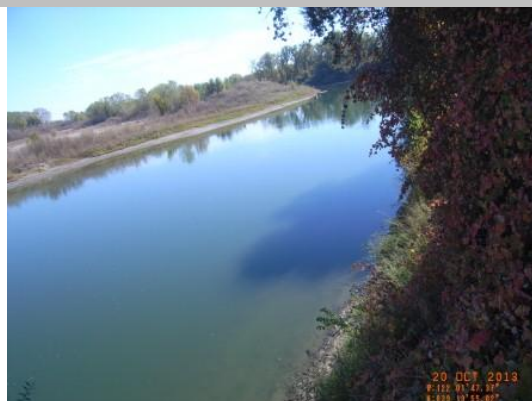
Photo 1 of 1 : FA_2018_ST0003_264_1_20180905_00001.jpg

LM Start	10.32	Rating **	M	Issue No.	1
LM End	10.41	Issue Type +	Ma	Location *	WS
Category	Supplemental			GPS Latitude/Longitude	
				Start	End
Item	2017 USACE Erosion Survey, DRAFT			39.331447 °	39.332716 °
				-122.029440 °	-122.029953 °
DWR ID	DWR_ST0003_01_f_2018_1				
Comment Code					
Inspector Comment					
2017 Site ID: SAC 157.7 R					
Status: Eroding					
2017 Field Notes: Vertical face of clay sand bank, new tree popout.					
Bank continues to erode.					
Site History: 2004 - Slowly eroding but near vertical with no vegetation to hold it. 2005 - Erosion is close to levee toe but not into the levee section yet. 2010 - Some new toe scour.

USACE 2013 Photo #1

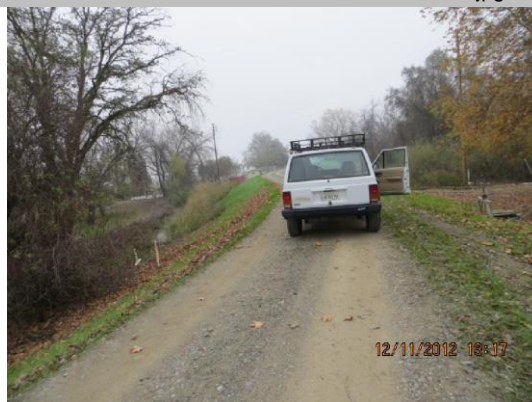
Photo 1 of 3 : UCIP_FA_2018_51734_47263.jpg

Comment Code					
Inspector Comment					
FS_ID:51734 DS_ID:17358 EP_NO: 9517 Repair Type: No Action Needed Crossing Status: Found UCIP Comments: 4/19/2017 No WS end found/ slide gate handle broken. (DWR Sutter Yard- Afreitag)10/31/2016 Slide gate handle is broken and no WS pipe end can be located. (DWR Sutter Yard-Afreitag)6/1/2016 WS slide gate handle is still broken. No WS pipe end was found.4/1/2015 Slide gate handle is still broken. The rest of the pipe appears in good condition. Broken slide gate handle found on WS.6/30/2014 Same as last inspection.12/18/2013 Same as last inspection.7/23/2013 Same as last inspection. FIELD_STRUCT_DESC: 48-inch corrugated metal drainage pipe through the levee, 14 feet below the crown. Slide gate in a 60-inch corrugated metal pipe (CMP) riser on the waterside (WS) slope. Slide gate in a concrete distribution box on the landside (LS) toe. (48-inch pipe [HLM 10.39] authorized under Automatic Board Order (ABO) issued as Permit No. 9517, 1974 - Griffin). [Additional Reference(s): DWR Levee Log, 2002. USACE Sacramento O&M Manual 136, March 1960 (HLM 10.47)]. FS Date: 5/1/2017 9:32:45 AM

Crown view: overview (both sides of the levee)

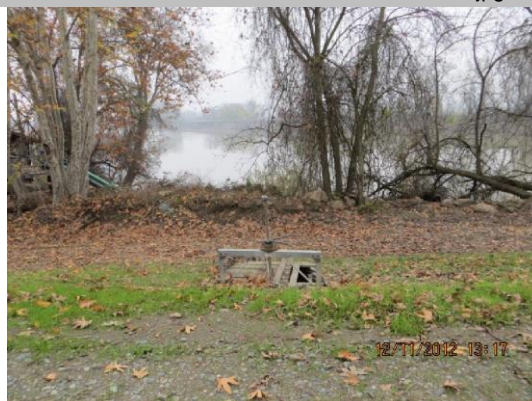
Photo 2 of 3 : UCIP_FA_2018_51734_47262.jpg

Item	DWR UCIP LMA Responsibility			39.270492 °	39.270492 °	
				-122.001306 °	-122.001306 °	
DWR ID	17358					
Comment Code						
Inspector Comment						
FS_ID:51734 DS_ID:17358 EP_NO: 9517 Repair Type: No Action Needed Crossing Status: Found UCIP Comments: 4/19/2017 No WS end found/ slide gate handle broken. (DWR Sutter Yard- Afreitag)10/31/2016 Slide gate handle is broken and no WS pipe end can be located. (DWR Sutter Yard- Afreitag)6/1/2016 WS slide gate handle is still broken. No WS pipe end was found.4/1/2015 Slide gate handle is still broken. The rest of the pipe appears in good condition. Broken slide gate handle found on WS.6/30/2014 Same as last inspection.12/18/2013 Same as last inspection.7/23/2013 Same as last inspection. FIELD_STRUCT_DESC: 48-inch corrugated metal drainage pipe through the levee, 14 feet below the crown. Slide gate in a 60-inch corrugated metal pipe (CMP) riser on the waterside (WS) slope. Slide gate in a concrete distribution box on the landside (LS) toe. (48-inch pipe [HLM 10.39] authorized under Automatic Board Order (ABO) issued as Permit No. 9517, 1974 - Griffin). [Additional Reference(s): DWR Levee Log, 2002. USACE Sacramento O&M Manual 136, March 1960 (HLM 10.47)]. FS Date: 5/1/2017 9:32:45 AM

Waterside view: overview of CMP riser

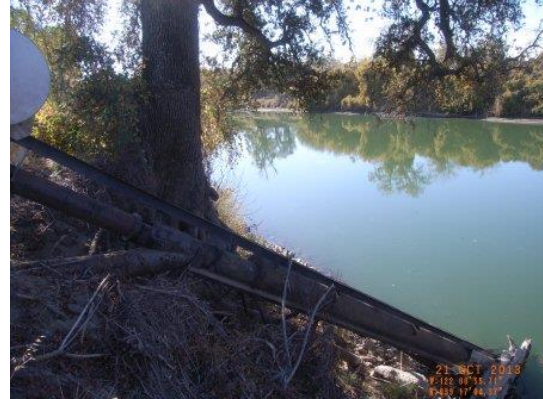
Photo 1 of 1 : FA_2018_ST0003_264_13_20180905_00010.jpg

LM Start	11.85	Rating **	M	Issue No.	13
LM End	11.90	Issue Type +	Ma	Location *	WS
Category	Supplemental			GPS Latitude/Longitude	
				Start	End
Item	2017 USACE Erosion Survey, DRAFT			39.284568 °	39.285298 °
				-122.015690 °	-122.015208 °
DWR ID	DWR_ST0003_01_f_2018_13				
Comment Code					
Inspector Comment					
2017 Site ID: SAC 152.8 L					
Status: Eroding					
2017 Field Notes: Minor new erosion observed.					
Site History: 2006 - Large rotational/mass failure in the bank with tree slump. Tough clayey toe material. 2007 - Site is between stone revetments with a pump station at the downstream end. 2010 - Erosion is into the levee toe. 2011 - Minor new erosion. 2012 - Minor new erosion.

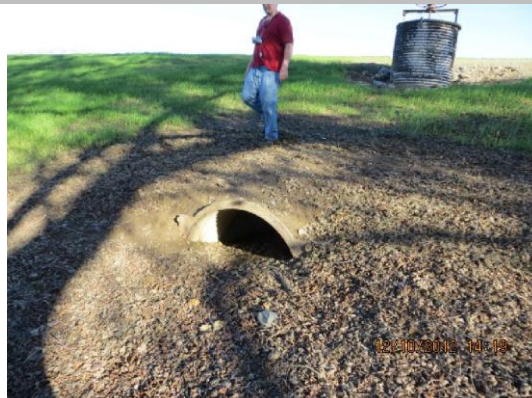
Photo 2 of 3 : UCIP_FA_2018_51749_47342.jpg

FS_ID:51749
DS_ID:17340
EP_NO: 9511
Repair Type: Non-Urgent
Crossing Status: Found
UCIP Comments: 4/20/2017 Abandoned- needs to be done properly. A oak tree has fallen down onto the WS pipe end. It does not appear to have damaged the pipe but it will need to be better inspected after the tree has been cleared away. (DWR Sutter Yard- AFreitag)10/31/2016 Abandoned. (DWR Sutter Yard- AFreitag)6/14/2016 Pipe was internally cleaned and camera inspected on 11/6/2015 by Nor-Cal Pipeline Services. The 48" cmp pipe section that runs through the levee was deemed to be in good condition. After the LS levee toe the pipe changes to a 48" concrete box culvert for under the roadway and that showed signs of some cracking. After the inspection the WS end was capped to keep sediment out until further abandonment can be achieved.4/16/2016 A wooden board has been placed on WS outlet of pipe to prevent sediment from entering pipe. This is a temporary repair measure by Sutter Yard until pipe can be grouted. Need to contact owner to ensure pipe's proper abandonment. Blockage of pipe outlet by wooden board or sediment will pose a hazard during high water. Pipe owner unclear, as landowner differs on LS and WS.4/2/2015 Pipe has been selected for internal camera inspection.Outlet pipe silted on WS. Inlet structure damaged on LS. Not properly abandoned.7/2/2014 Same as last inspection.12/19/2013 Same as last inspection.7/23/2013 Same as last inspection.

Waterside view: overview of CMP riser and outlet pipe

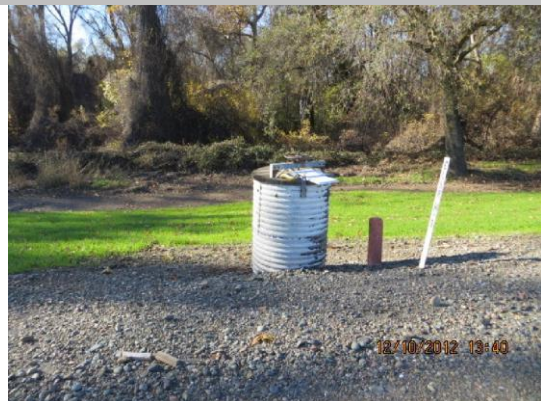
Photo 1 of 3 : UCIP_FA_2018_51752_47356.jpg

Comment Code					
Inspector Comment					
FS_ID:51752 DS_ID:17330 EP_NO: 9508 Repair Type: No Action Needed Crossing Status: Found UCIP Comments: 4/20/2017 Abandoned- needs to be done so properly. (DWR Sutter Yard- AFreitag)10/31/2016 Appears abandoned. WS pipe end buried. (DWR Sutter Yard- AFreitag)6/14/2016 Pipe was internally cleaned and camera inspected on 11/17/2015 by Nor-Cal Pipeline Services. Pipe section through levee is 86ft long and showed some signs of rusting but no visible holes or other deterioration was found. After the inspection the WS end was capped and reburied until further abandonment can be achieved.4/14/2016 Concrete box on LS cleared of sediment.4/2/2015 Same as last inspection. Concrete box on LS silted in. If abandoned it should be done so properly.7/2/2014 Same as last inspection.12/19/2013 Same as last inspection.7/23/2013 Same as last inspection. FIELD_STRUCT_DESC: 24-inch corrugated metal drainage pipe through the levee, 14 feet below the crown. Slide gate in a 36-inch corrugated metal pipe (CMP) riser on the waterside (WS) slope. Concrete distribution box on the landside (LS). (24-inch pipe [HLM 14.5] authorized under Automatic Board Order (ABO) issued as Permit No. 9508, 1974 - Jones). [Additional Reference(s): DWR Levee Log, 2002. USACE Sacramento O&M Manual 136, March 1960 (HLM 14.5)]. FS Date: 5/1/2017 10:34:48 AM

Waterside view: CMP riser with slide gate

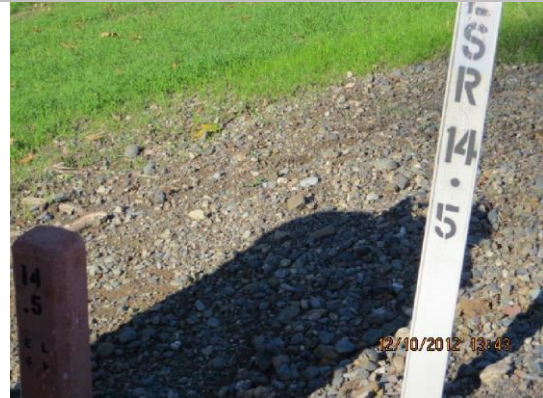
Photo 2 of 3 : UCIP_FA_2018_51752_47361.jpg

Waterside view: levee mile marker

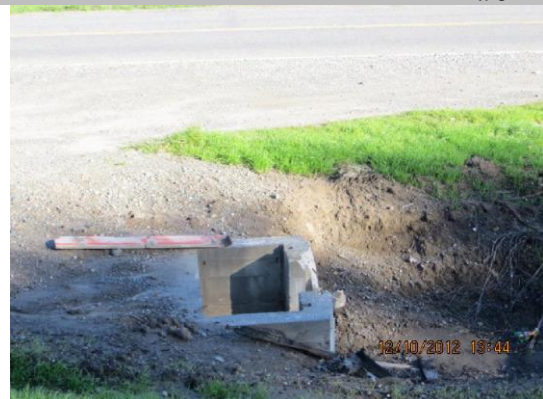
Photo 3 of 3 : UCIP_FA_2018_51752_47360.jpg

Landside view: overview of distribution box

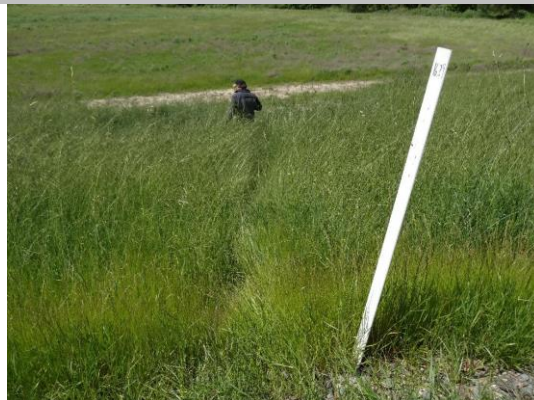
Photo 1 of 3 : UCIP_FA_2018_51759_75096.jpg

Comment Code					
Inspector Comment					
FS_ID:51759 DS_ID:17337 EP_NO: N/A Repair Type: Non-Urgent Crossing Status: Found UCIP Comments: 4/20/2017 Abandoned- needs to be done so properly. (DWR Sutter Yard- AFreitag)11/1/2016 Abandoned. Pipe is buried and not visible but a white marker on WS shoulder shows its location. (DWR Sutter Yard- AFreitag)6/15/2016 Pipe was dug up and internally cleaned and camera inspected on 11/19/2015 by Nor-Cal Pipeline Services. Pipe section through the levee is 88ft long and showed signs of rusting but no holes or other deterioration was found. The WS flap gate was broken during excavation but doesnt pose an issue as the pipe was capped and reburied until further abandonment can be achieved. Unfortunately the pipe was not photographed when exposed.4/14/2016 Same as last inspection.4/2/2015 Unable to locate. Pipe has been selected to be dug up and internally camera inspected.7/2/2014 Unable to locate.12/19/2013 Unable to locate7/23/2013 Same as last inspection. Unable to locate. FIELD_STRUCT_DESC: 42-inch corrugated metal drainage pipe through the levee, 16.5 feet below the crown. Metal flap gate on the waterside (WS) silted over. Brick "U" shaped headwall on the WS toe. [Additional Reference(s): DWR Levee Log, 2002. USACE Sacramento O&M Manual 136, March 1960 (HLM 16.29)]. FS Date: 5/1/2017 10:41:07 AM

View from crown down WS slope at location of crossing.

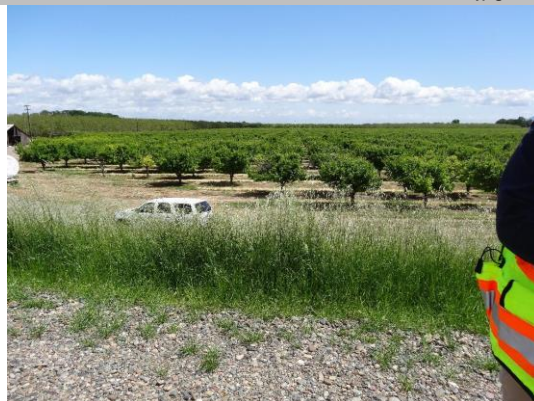
Photo 2 of 3 : UCIP_FA_2018_51759_75097.jpg

View of LS from crown at location of crossing.

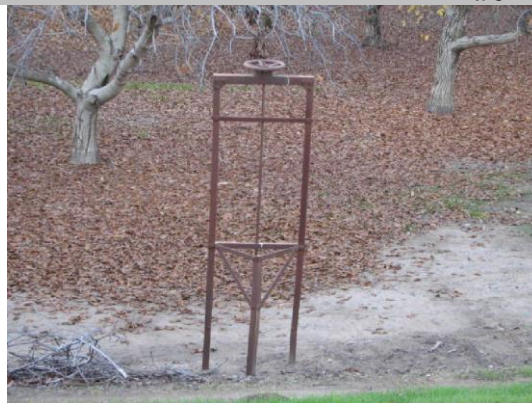
Photo 2 of 3 : UCIP_FA_2018_51762_47386.jpg

FS_ID:51762
DS_ID:17329
EP_NO: N/A
Repair Type: Non-Urgent
Crossing Status: Found
UCIP Comments: 4/20/2017 Abandoned- needs to be done properly. Pipe had a small leak during high water and is believed to be caused by the screw gate not being fully closed before it was reburied after its internal inspection. (DWR Sutter Yard- AFreitag)11/1/2016
Abandoned. (DWR Sutter Yard- AFreitag)6/15/2016 Pipe was dug up and internally cleaned and camera inspected on 11/18/2015 by Nor-Cal Pipeline Services. Pipe section through levee is about 93.8ft long. Inspection showed signs of rusting but no holes or other deterioration was found. WS end and slidegate were photographed, LS end was not. After the inspection pipe ends were capped and reburied until further abandonment can be achieved.4/2/2015 WS pipe end was dug up in preparation for internal camera inspection. Only steel slide gate structure found on waterside.7/2/2014 Same as last inspection.12/19/2013 Same as last inspection.7/24/2013 Same as last inspection.

Waterside view: slide gate steel structure

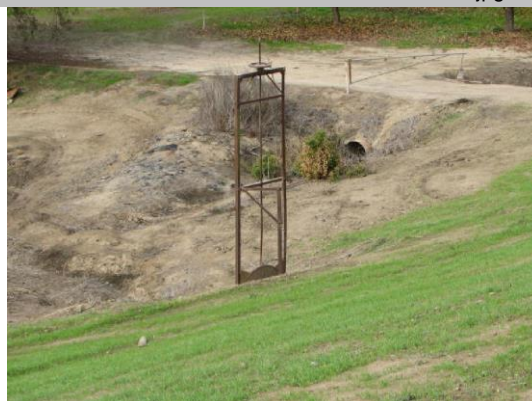
Photo 1 of 3 : UCIP_FA_2018_51770_47399.jpg

FS_ID:51770
DS_ID:17345
EP_NO: N/A
Repair Type: No Action Needed
Crossing Status: Found
UCIP Comments: 4/20/2017 Crossing appears to be in good condition. (DWR Sutter Yard- AFreitag)11/1/2016 Crossing appears to be in good condition. (DWR Sutter Yard- AFreitag)6/16/2016 Pipe was internally cleaned and camera inspected on 11/19/2015 by Nor-Cal Pipeline Services. Pipe is 155ft in total length and the inspection showed some minor rusting but no holes or other deformations were found. Pipe is still used by the landowner for irrigation and the sloughing near the WS end was repaired and rocked to prevent future sloughing or erosion.4/14/2016 Sloughing repaired by Sutter Yard with rock revetment.4/2/2015 Same as last inspection. Pipe has been selected for internal camera inspection.Sloughing at outlet and levee slope is damaged due to sloughing.7/2/2014 It is not an abandoned crossing. Sloughing at outlet and levee slope is damaged due to sloughing.12/19/2013 Same as last inspection.7/24/2013 Same as last inspection.

Waterside view: overview of sliding gate structure

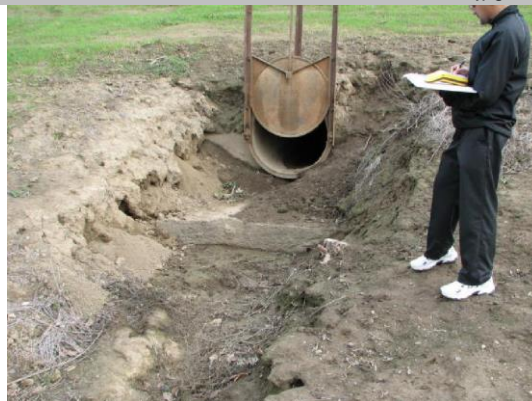
Photo 2 of 3 : UCIP_FA_2018_51770_47398.jpg

Waterside view: outlet pipe with concrete headwall and floor apron.

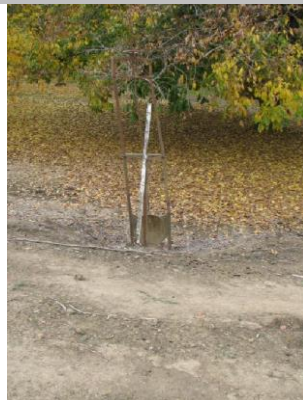
Photo 1 of 3 : UCIP_FA_2018_51771_47442.jpg

FS_ID:51771
DS_ID:17346
EP_NO: 9503
Repair Type: No Action Needed
Crossing Status: Found
UCIP Comments: 4/20/2017 Crossing appears to be in good condition.
(DWR Sutter Yard- A Freitag)11/1/2016 Crossing appears to be in good condition. (DWR Sutter Yard- A Freitag)6/16/2016 Pipe was internally cleaned and camera inspected on 11/19/2015 by Nor-Cal Pipeline Services. 129.5 ft (starting from the WS end) was inspected to get get us through the levee prism but the LS end was never found. Pipe showed no signs of rust or damage.4/14/2016 Inlet structure still filled with soil.4/2/2015 Same as last inspection. Pipe has been selected for internal camera inspection.According to local people, the crossing is functional. The gap between 8-inch and 24-inch pipes is grouted with cement. Inlet structure is filled with soil.7/2/2014 Same as last inspection.12/19/2013 Same as last inspection.7/24/2013 Same as last inspection.

Waterside view: overview of slide gate structure

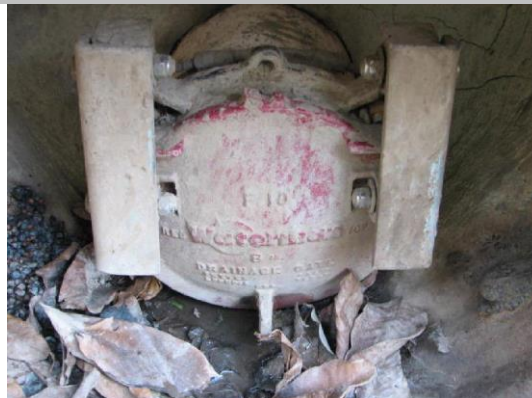
Photo 3 of 3 : UCIP_FA_2018_51771_47440.jpg

FIELD_STRUCT_DESC: 24-inch corrugated metal drainage pipe through the levee, 19 feet below the crown. 8-inch steel pipe sleeved through the 24-inch pipe. Annular space cement grouted. Slide gate at the waterside (WS) toe. Concrete inlet box on the landside (LS). (24-inch pipe [HLM 18.74] authorized under Automatic Board Order (ABO) issued as Permit No. 9503, 1974 - Baird). [Additional Reference(s): DWR Levee Log, 2002. USACE Sacramento O&M Manual 136, March 1960 (HLM 18.74)].
FS Date: 5/1/2017 10:53:44 AM

Waterside view: 8-inch pipe and drain gate

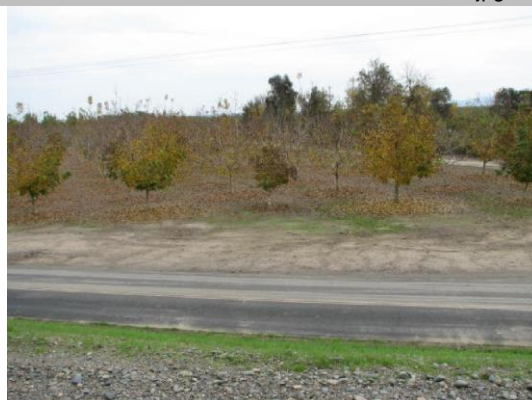
Photo 2 of 3 : UCIP_FA_2018_51773_47446.jpg

Comment Code					
Inspector Comment					
FS_ID:51773 DS_ID:17347 EP_NO: N/A Repair Type: No Action Needed Crossing Status: Found UCIP Comments: 4/20/2017 Abandoned- plugged. (DWR Sutter Yard-AFreitag)11/1/2016 Abandoned/plugged. (DWR Sutter Yard-AFreitag)6/16/2016 Internal camera inspection was done on 11/19/2015 by Nor-Cal Pipeline Servies. Pipe was inspected starting from the WS end and inspected upto the grout plug that is 13.7ft into the pipe. Pipe was then capped and reburied until further abandonment can be achieved.4/2/2015 WS end of pipe was dug up in preparation for internal camera inspection. Only steel slide gate structure found on WS.7/2/2014 Same as last inspection.12/19/2013 Same as last inspection.7/24/2013 Same as last inspection. FIELD_STRUCT_DESC: *ABANDONED* 36-inch corrugated metal drainage pipe through the levee, 21.7 feet below the crown. Slide gate at the waterside (WS) toe. Pipe grouted on the WS end. [Additional Reference(s): DWR Levee Log, 2002. USACE Sacramento O&M Manual 136, March 1960 (HLM 19.24)]. FS Date: 5/1/2017 10:55:06 AM

Landside view: overview (no pipes)

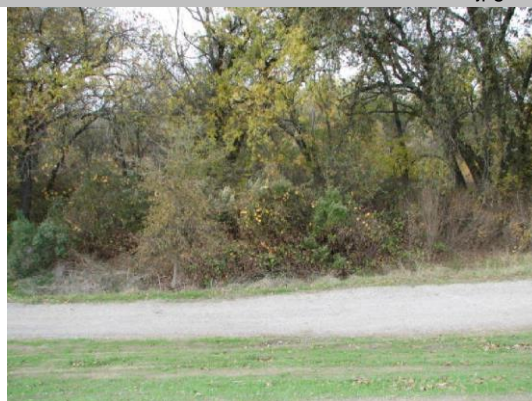
Photo 1 of 3 : UCIP_FA_2018_51775_47449.jpg

Comment Code					
Inspector Comment					
FS_ID:51775					
DS_ID:17487					
EP_NO: N/A					
Repair Type: Non-Urgent					
Crossing Status: Found					
UCIP Comments: 4/20/2017 Abandoned- needs to be done so properly. (DWR Sutter Yard- A Freitag)11/1/2016 Abandoned.(DWR Sutter Yard- A Freitag)6/3/2016 Abandoned crossing.4/2/2015 Same as last inspection. Slide Gate WS not found. An abandoned pump and steel pipe found on WS. A 6 ft x 8 ft concrete distribution box with a CMP found on LS. Box filled with soil. An abandoned crossing.7/2/2014 Same as last inspection.12/19/2013 Same as last inspection.7/24/2013 Same as last inspection.					
FIELD_STRUCT_DESC: *ABANDONED* 36-inch corrugated metal drainage pipe through the levee, invert 21.7 feet below the crown.					
Abandoned pump and steel pipe found on the waterside (WS). 6 foot by 8 foot concrete distribution box with the 36-inch corrugated metal pipe found on the landside (LS). [Additional Reference(s): USACE Sacramento O&M Manual 136, March 1960 (HLM 19.61)].

Waterside view: overview

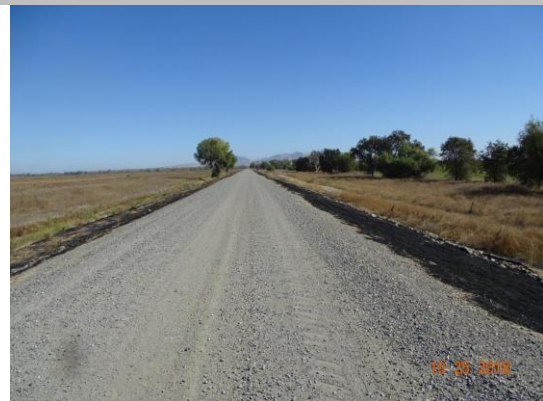
Photo 1 of 1 : FA_2018_ST0003_265_3_20181102_00004.jpg

LM Start	0.37	Rating **	A	Issue No.	3
LM End	0.37	Issue Type +	Ma	Location *	LS
Category	Earthen Levee			GPS Latitude/Longitude	
				Start	End
Item	Vegetation			39.231415 °	39.231415 °
				-121.989060 °	-121.989060 °
DWR ID	DWR_ST0003_02_f_2018_3				
Comment Code					
V1 : Control annual grass and weeds on the levee slopes and easements.					
Inspector Comment					
The vegetation was burned off of both slopes.

View of no vegetation on both slopes.

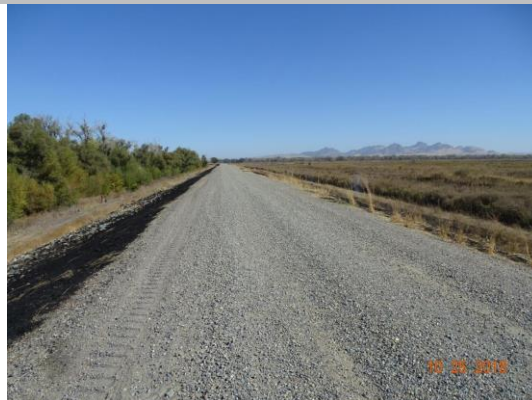
Photo 1 of 1 : FA_2018_ST0003_266_1_20181102_00002.jpg

LM Start	0.67	Rating **	A	Issue No.	1
LM End	0.67	Issue Type +	Ma	Location *	LS
Category	Earthen Levee			GPS Latitude/Longitude	
				Start	End
Item	Vegetation			39.237682 °	39.237682 °
				-121.981938 °	-121.981938 °
DWR ID	DWR_ST0003_03_f_2018_1				
Comment Code					
V1 : Control annual grass and weeds on the levee slopes and easements.					
Inspector Comment					
The vegetation was burned off of both slopes.

View of no vegetation on both slopes.

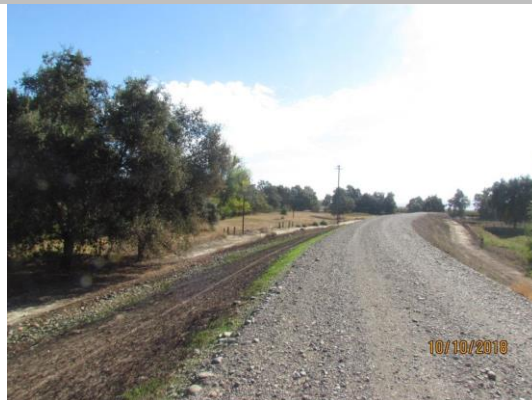
Photo 1 of 1 : FA_2018_ST0003_267_1_20181105_00001.jpg

LM Start	0.10	Rating **	A	Issue No.	1
LM End	0.10	Issue Type +	Ma	Location *	LS
Category	Earthen Levee			GPS Latitude/Longitude	
				Start	End
Item	Vegetation			39.337763 °	39.337763 °
				-122.020342 °	-122.020342 °
DWR ID	DWR_ST0003_04_f_2018_1				
Comment Code					
V1 : Control annual grass and weeds on the levee slopes and easements.					
Inspector Comment					
The vegetation has been removed from both slopes.

View of no vegetation on both slopes.

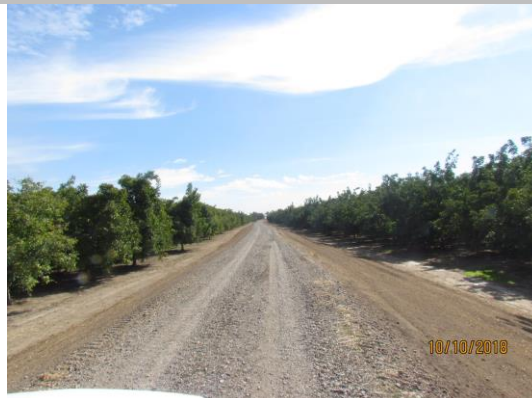
Photo 1 of 1 : FA_2018_ST0003_268_2_20181105_00003.jpg

LM Start	0.35	Rating **	A	Issue No.	2
LM End	0.35	Issue Type +	Ma	Location *	LS
Category	Earthen Levee			GPS Latitude/Longitude	
				Start	End
Item	Vegetation			39.343242°	39.343242°
				-122.016578°	-122.016578°
DWR ID	DWR_ST0003_05_f_2018_2				
Comment Code					
V1 : Control annual grass and weeds on the levee slopes and easements.					
Inspector Comment					
The vegetation has been removed from both slopes.

View of no vegetation on both slopes.
